National Register of Historic Places Registration Form

historic name Jones Motor Company
other names/site number _____

street & number 3226 Central Avenue SE not for publication
city or town Albuquerque vicinity
state New Mexico code NM county Bernalillo code 001 zip code 87108

Historic and Architectural Resources of Rt. 66 through NM
Bernalillo County, New Mexico

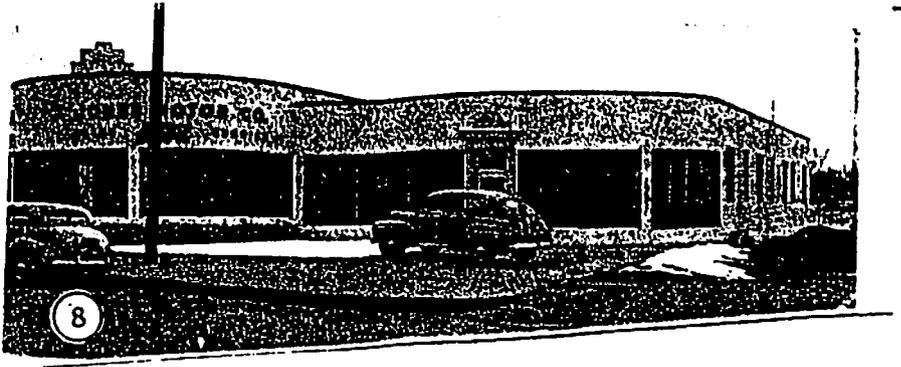
Tower detail
Looking SW

architectural features 1 story, flat roof w/ brick coping, stepped & molded tower facing NE, lg. showroom w/ lg. commercial lights to W., curved walls, garage bay (E side); metal casements & fixed windows; door transoms; comm. glass & wd. panel doors	describe: Addition to W (1946) Fill-in of tower entrance, some windows
	surroundings comm. strip
	relationship to surroundings similar <input checked="" type="checkbox"/> not similar <input type="checkbox"/>
	district potential yes <input type="checkbox"/> no <input checked="" type="checkbox"/>
	significance eligible <input checked="" type="checkbox"/> of none interest <input type="checkbox"/>

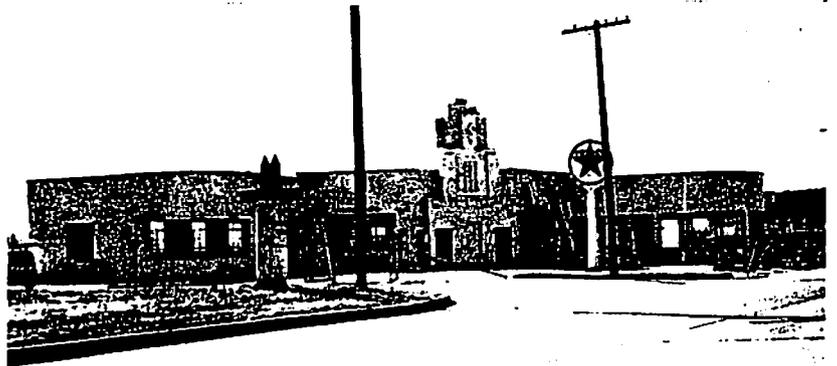
BBQ Progress
Nov. 1939

The new and modern Service Station and Garage located at 3226 East Central. Ralph Jones is the manager. Flinn and Stamm were the contractors in charge, and Tom Danahy, architect.
