**NATIONAL REGISTER OF HISTORIC PLACES
REGISTRATION FORM**

1. NAME OF PROPERTY OTERO'S 66 SERVICE

HISTORIC NAME: Phillips Service Station
OTHER NAME/SITE NUMBER: Sam's Tire and Lube

Otero's 66 Service
Los Lunas, Valencia County, New Mexico

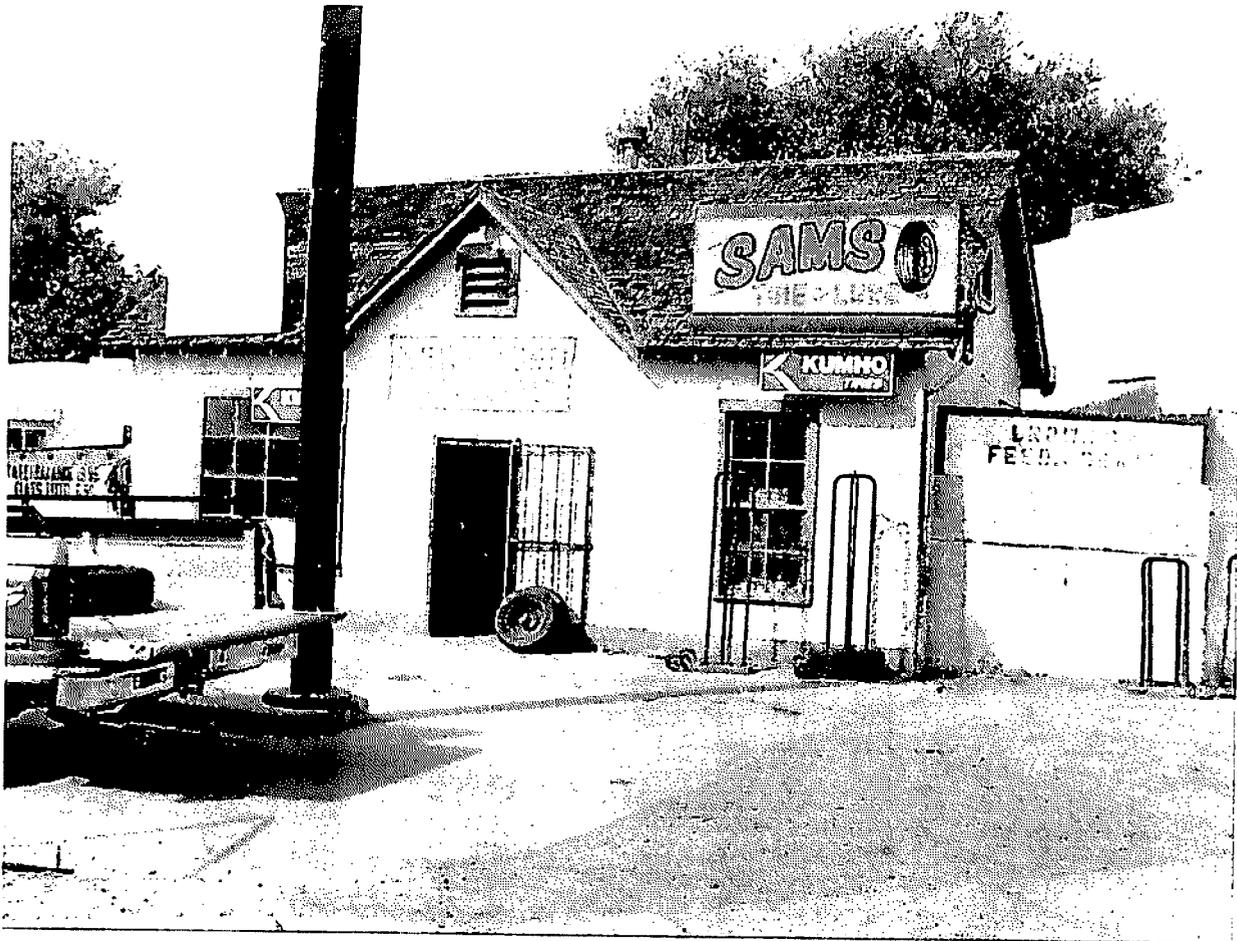
Photo 1: Front and south facades; looking northwest (October 2001)

The building is raised on a concrete foundation, and reveals exposed rafters and a slight overhang, while faintly bungalowoid, suggests the early stages in gas station design when many stations retained domestic characteristics (see Photo 1). Louvered vents appear in each of the gable ends. Fenestration includes both wood casement and 4/4 double-hung wood-sash windows with the contrasting window types contributing to the asymmetry of the generally balanced front elevation. The current front entry, a metal frame commercial glass door, is a replacement.

Photo 1 of 1

Front and south facades

Facing northeast
